**NASA Technical Memorandum 104574**

**Four Space Application Material  
Coatings on the Long-Duration  
Exposure Flight**

**John J. Scialdone and Carroll H. Clatterbuck**

**November 1992**

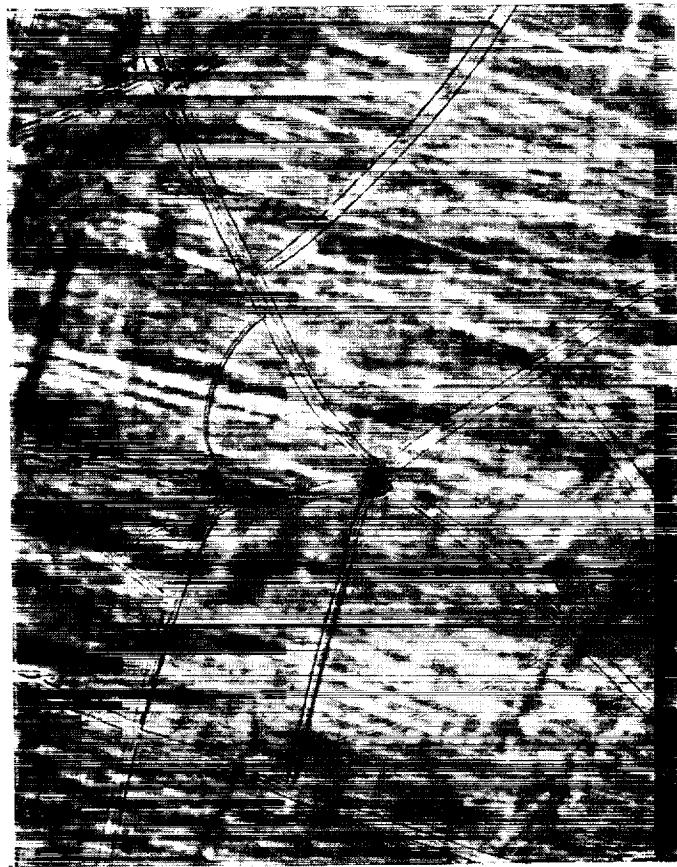
**Visual Inspection**--The surface is clear and transparent with no noticeably changed features (Figures 12 and 13).

**High-Magnification Inspection**--Optical magnification shows banded networks with areas of contamination (possibly impacts) at focal points of several bands (Figures 12 and 13). The network of crack lines may have originated from solar exposure and from additional material losses causing thermal cracking.

Figure 12. Devolatilized RTV-615 bonded on Al with SS 4155 Primer (200 X).

Figure 13. Devolatilized RTV-615 bonded on Al with SS 4155 Primer (25 X).
